# Service Sheets for the

# Norton

## Commando

## SERVICE RELEASE

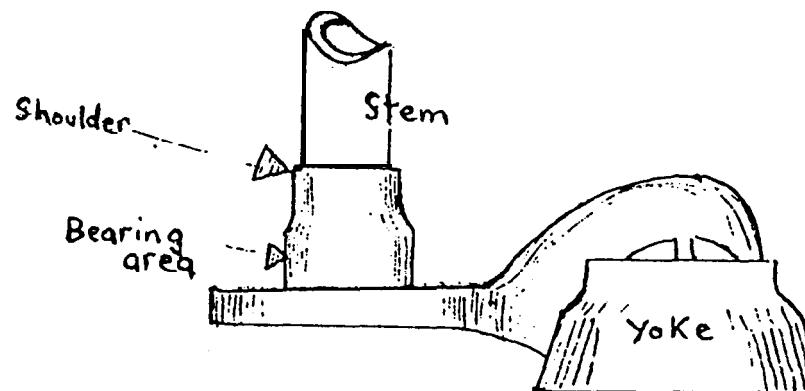
EXPLANATION: During assembly of the fork lower lug and stem to the steering head tube of the frame, it is possible for the shoulder of the stem to become lodged against the lower headrace. If this is not realised and the fork should turn on to full lock, the thick cross section of the yoke will lodge against the lock stop on the frame. As the stem is drawn home into the bearings by tightening of the large stem nut, the yoke cannot follow and will either be distorted beyond further use or fractured in the area where the stem joins the yoke.

ACTION: To prevent damage, ensure that the correct lower portion of the stem is central in relation to the lower bearing inner race before the stem nut is tightened.

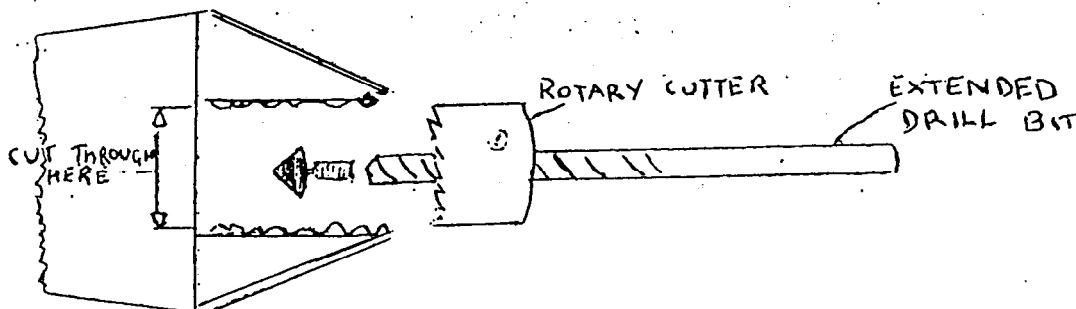
EXPLANATION: We are advised of sales resistance to machines fitted with the latest reverse cone silencers with perforated tubes in the end cones due to a whistling effect over subdued exhaust note.

ACTION: Using a 13/16" diameter sheet metal rotary cutter on an extended drill bit cut a hole through the blanking plate as shown below.

This modification makes it essential to change the main jets to 210 and to drop the needle in the clip to the top (No.1) groove. If carburation is not corrected after this silencer modification, severe damage will be caused. Observe that the resultant exhaust note still falls within legal requirements.

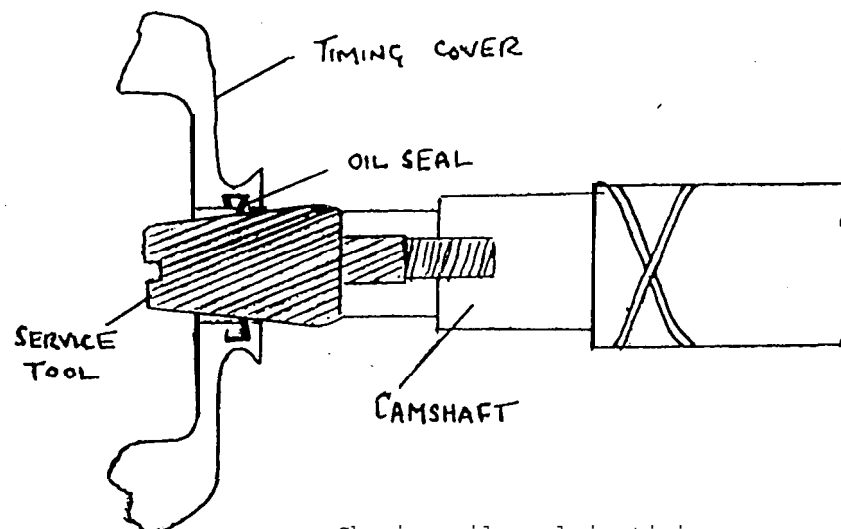
- PARTS INVOLVED: 06-1359 Camshaft oil seal guide.
- EXPLANATION: When the timing cover is offered over the end of the camshaft, the oil seal at the contact breaker housing must pass over the large diameter of the camshaft. This invariably causes damage to the pressure lip of the seal. A special tool is provided in **the tool kit** to screw into the end of the camshaft and guide the seal home without damage.

Showing oil seal in timing cover  
being slid over guide onto camshaft.

- ACTION: Screw the service tool into the end of the camshaft, finger tight, before the timing cover is offered up. Smear the tool taper with clean oil and push the cover gently **into place** so that the seal slides easily over the tool and onto the camshaft. The tool has a screwdriver slot and can be removed simply at this stage.

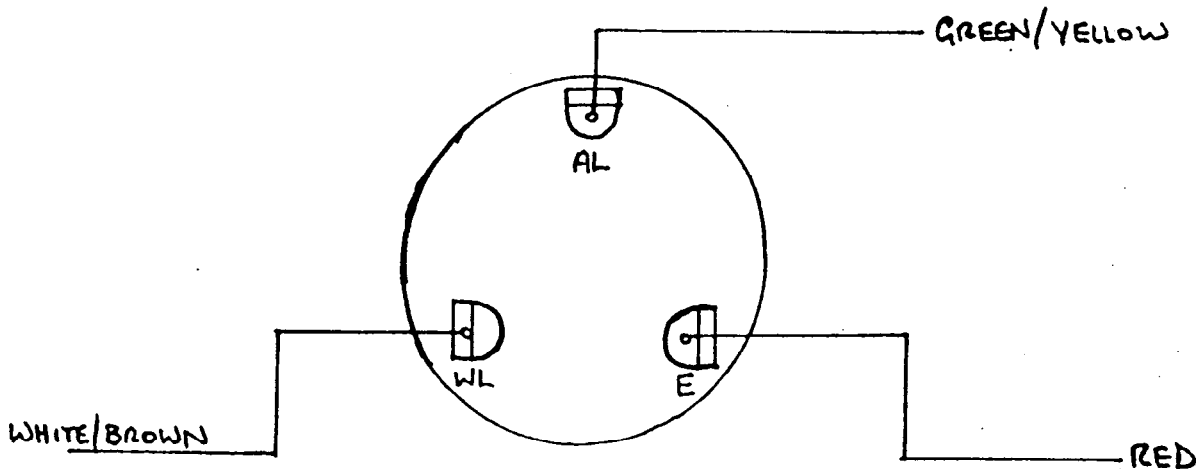
EXPLANATION: Instances have been reported of the charge warning light assmulator, being inoperative ie. the light has remained on when charging has been taking place. Investigation suggests that affected machines have had the leads to the assmulator connected incorrectly.

ACTION: Remove the fuel tank to gain access to the voltage assmulator connections. Ensure that the leads are connected as shown below.

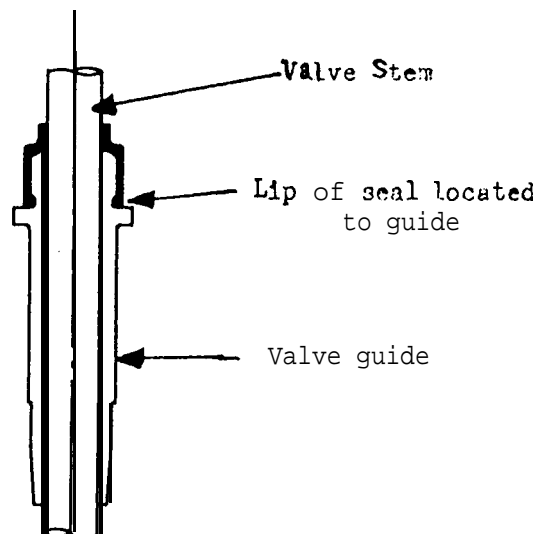
Service Release N45 detailed the introduction and fitting of new inlet valve guides with seals. We have subsequently **encountered** instances of the seals being fitted incorrectly.

It is most important for the lip of the seal to locate all round in the groove of the inlet valve guide. The illustration below shows the seal fitted correctly. If the lip is not located the seal **will** ride up and down with the valve stem rather than providing a wiping action to prevent oil passing between the valve and guide.

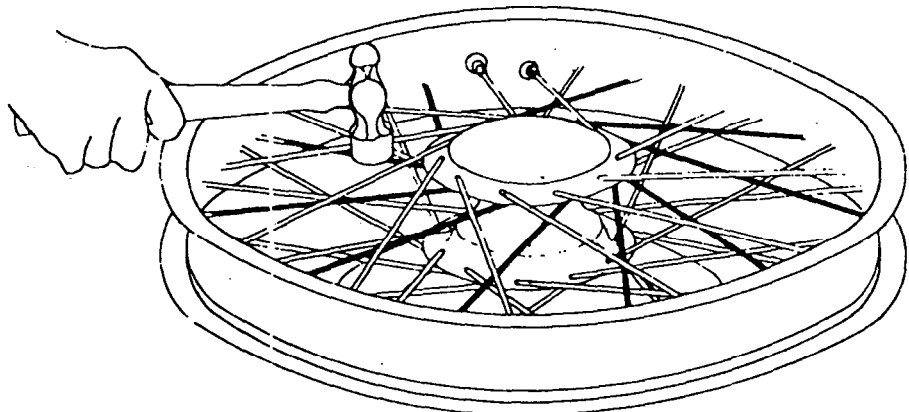
The spoking arrangement of the disc brake type of front wheel requires periodic attention to correct possible loss of spoke tension. To eliminate the need for regular attention, the following technique which is now applied to all disc brake wheels at the factory should be undertaken at the earliest opportunity (prior to delivery where possible):

- 1) With all spokes lightly tensioned, tighten left hand side inboard spokes.
- 2) Tighten left hand side outboard spokes.
- 3) As shown in the illustration below, set the left hand side inboard spokes straight (shaded heavily) by tapping the bowed portion of the spokes with a  $\frac{1}{2}$ lb. (.225Kg) hammer and drift 3" (76.2mm) from the centre of the spoke head.

- 4) Retighten the left hand side inboard spokes.
- 5) Tighten the right hand side inboard spokes.
- 6) Tighten the right hand side outboard spokes.
- 7) Recheck wheel for truth and align as necessary.

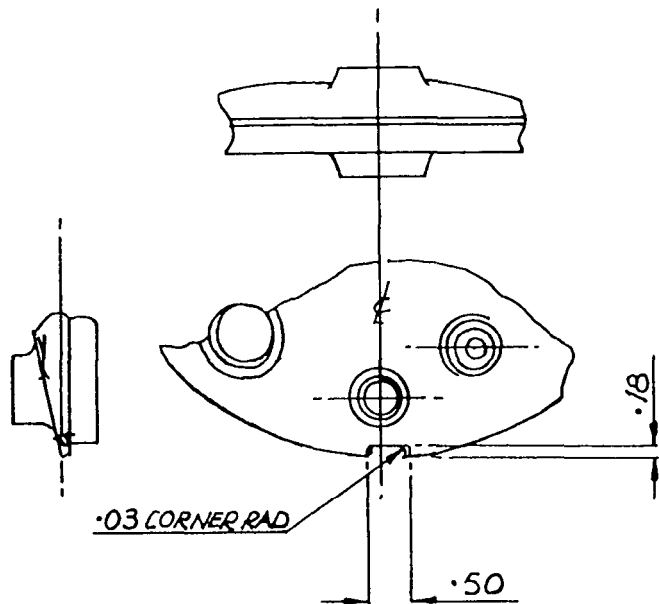
<u>CATEGORY OF RELEASE:</u>	4	(as over-leaf)	No. N3/8
<u>NATURE OF RELEASE:</u>	Water in front brake..		
<u>MODELS AFFECTED:</u>	1971 and 1972 Commando with drum front brake.		
<u>DISTRIBUTION:</u>	Worldwide (for general distribution).		
<u>EXPLANATION:</u>	<p>During 1971, drain holes were incorporated in the brake drum, breaking through the casting between the first and second fin from the drive (left) side to eject water entering the drum. From time to time the drain holes should be cleared, after removal of the brake cover plate, by the use of a suitable piece of wire or a jet of compressed air.</p> <p>A further improvement in water drainage can be achieved by a simple modification to the brake cover plate by the modification shown below.'</p>		
<u>ACTION:</u>	<p>Check that the drum drain holes are clear, then proceed to modify the brake plate by removal of a small section at the bottom of the anchor plate as illustrated. It is important to radius the corners of the new water exit slot.</p>

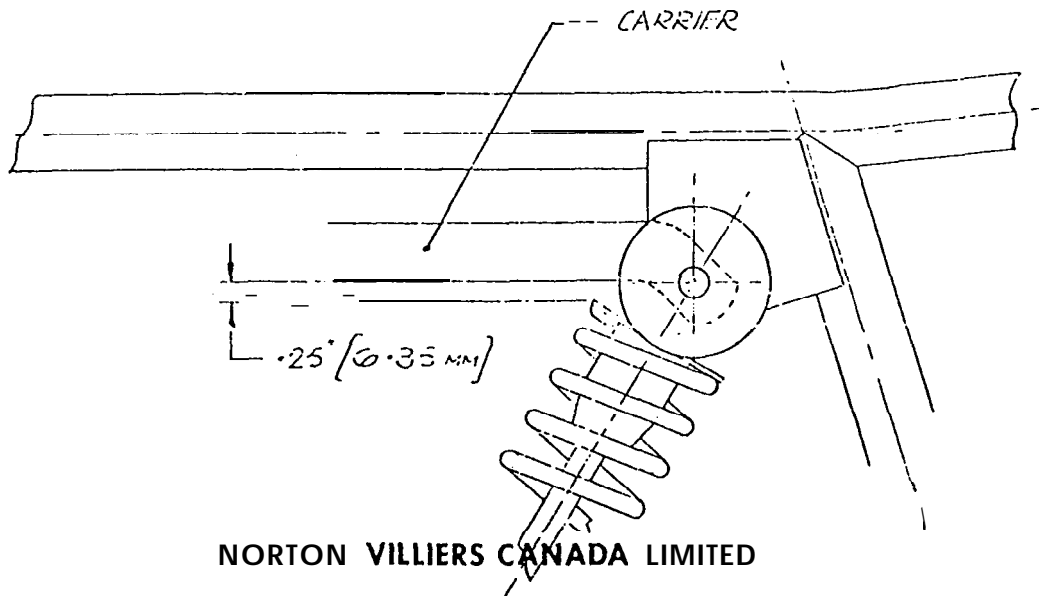
Any contact or loading at this point nullifies the fully floating effect of the bonded ferrule and bush assembly on the damper unit, and applies assymetric thrust onto the unit itself. In extreme cases the fixing eye can be torn off the damper body.

ACTION: Only fit pannier equipment or rear carriers that are strongly and stiffly braced from both left and right support plates to a point approximately 12 inches (30cm minimum) rearwards from the dual seat knurled fixing nut. Unless the carrier frame is adequately braced, overload and distortion of the rear frame loop will inevitably occur.

Ensure the carrier frame loop that locates forward onto the suspension unit top bolt lies completely clear and free of the top fixing eye, and/or the top spring collar.

Remember the bushes are further compressed with rider and passenger weight on the machine, whilst loading the pannier/carrier equipment may further reduce the available clearances. The minimum static clearance as illustrated should be .25in. (6.35mm).
