# Service Sheets for the

# Norton

## Commando

## SERVICE RELEASE

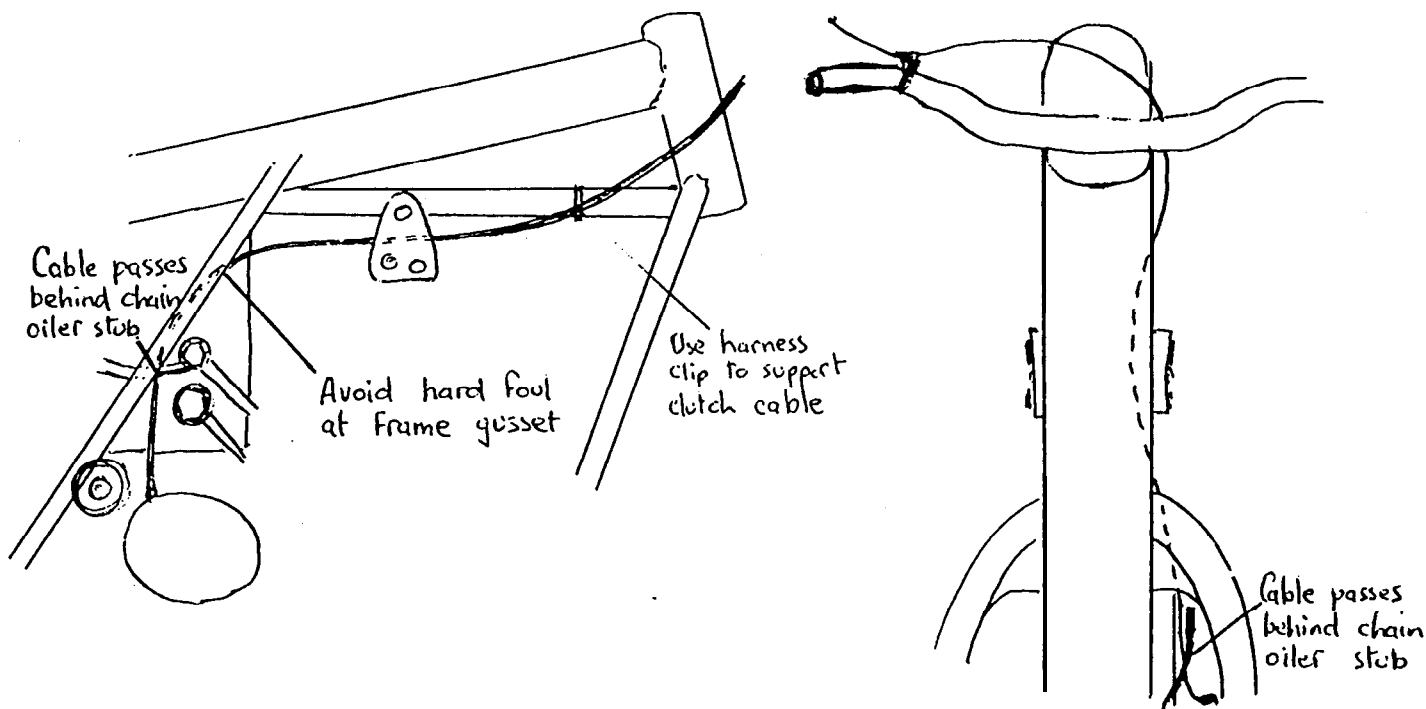
NO: N.12

- NATURE OF RELEASE: Stiff Clutch Action.
- MODELS AFFECTED: Commando - All editions.
- DISTRIBUTION: Worldwide.
- PARTS INVOLVED: 060930 and 060919 Clutch Cables.
- EXPLANATION: Due to incorrect routing of the clutch cable there have been certain complaints of a stiff clutch action. This is not due to any shortcoming in either the clutch or clutch thrust mechanism but is purely attributable to the run of the cable.
- ACTION: Note the diagram below and re-route the clutch cable in accordance with this to eliminate any tight bends. On completion, run a little thin oil down the inner cable to ensure freedom of movement and the problem will be eliminated.

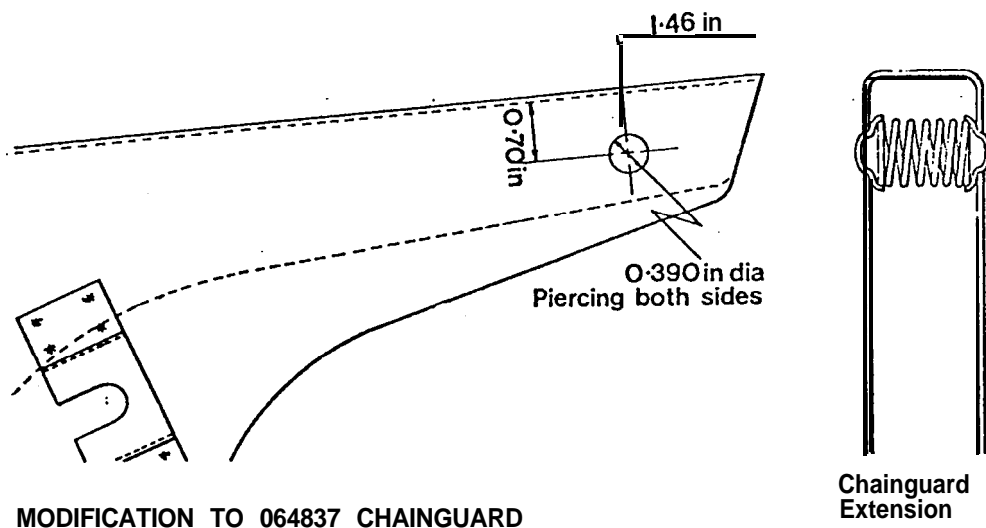
- CATEGORY OF RELEASE: 5
- NATURE OF RELEASE: Introduction of rear chainguard extension
- MODELS AFFECTED: All Commando
- DISTRIBUTION: Worldwide (General distribution)
- EXPLANATION: A new rear chainguard has been introduced on assembly subsequent to engine number 307091 which incorporates a detachable extension piece.
- The new chainguard 064837 is similar to the superseded part 061865 but incorporates two additional pierced holes into which the additional plastic extension piece locates.
- ACTION:
- To replace existing chainguard 061865 use the following components:-

1	064837	Chainguard
1	064822	Chainguard extension
2	06L. 823	Chainguard extension button
1	064824	Chainguard extension spring
  - To convert existing chainguard 061865 to accept and fit the new chainguard extension assembly, modify as shown below.

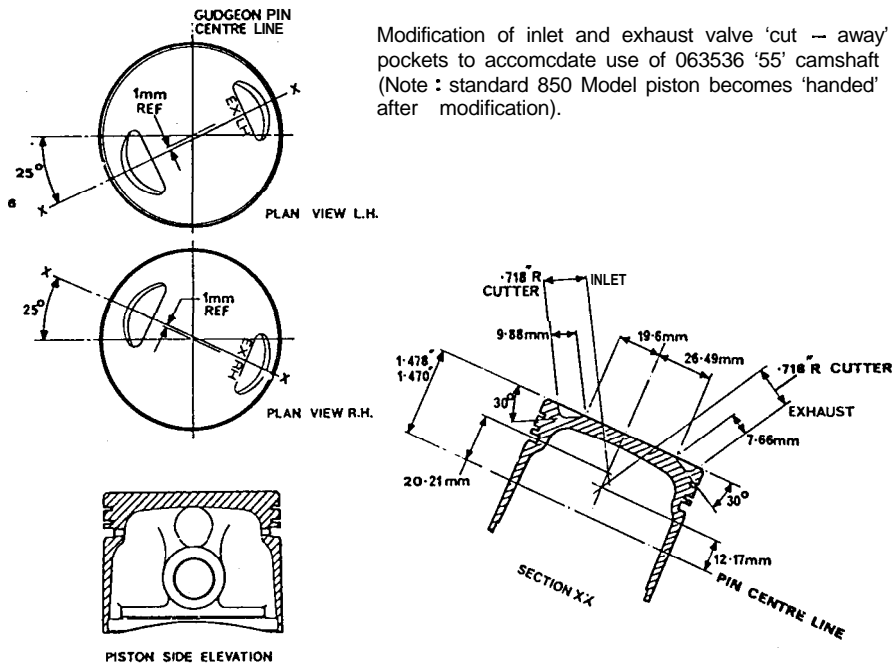
FIG. 1. PISTON CROWN MODIFICATION

Modification of inlet and exhaust valve 'cut - away' pockets to accommodate use of 063536 '55' camshaft (Note : standard 850 Model piston becomes 'handed' after modification).

1. Piston Conversion of the standard 850 piston 063836 to sports condition involves deepening the valve 'cut-away' pockets in accordance with the dimensions given in Fig. 1.

The cut-aways require re-machining to the amended conditions as shown to allow for the additional 'valve drop' created by the use of the new Camshaft 063536. The head diameters of both the inlet and exhaust valves should be measured → ensure head diameters do not exceed 1.490 in. (37.85 mm) inlet, and 1.302 in. (33.07 mm) exhaust. This will avoid any possibility of subsequent 'hook up' when using 063536 Camshaft in the higher engine R.P.M., range.
